Arboricultural Inventory and Report

For:
UBC Properties Trust

Site Location:
Jack Bell Renewal Project

Date: November 8, 2022

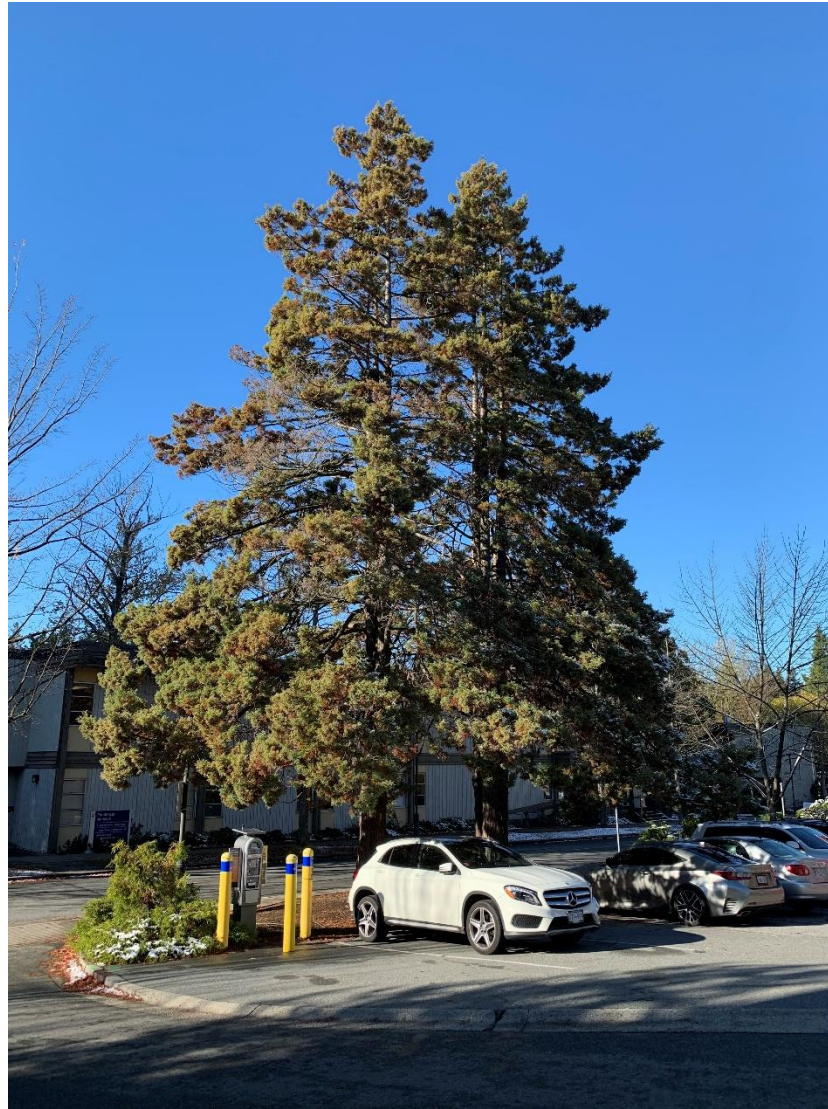
Photo 3. Looking north-east at trees 1182 and 1183.

Tree #	Botanical Name	DBH (cm)	Ht (m)	Health and Condition Rating	Comments	Useful Life Expectancy	Tree Retention Comments	Transplant Cost and Effort	Relocation Success Rate	Tolerance to Disturbance
1183	<i>Chamaecyparis pisifera</i>	103	18	Poor	Codominant stem tree at 1 m with acute bark inclusion. Seam from union to base of tree. Triple leaders with SWleaders having acute bark inclusion and seam running down trunk. Experiencing crown dieback. Evident girdling roots. UBC tree tag 4838. DBH 59+44.	~15 years	Low	Large	Low	Moderate
1184	<i>Fraxinus americana</i>	23	14	Moderate	Single stem tree. Open crown. Asymmetrical crown. Minor deadwood. Decent vigour. UBC tree tag 9551 being consumed into trunk.	>50 years	Medium	Medium	Moderate	Moderate
1188	<i>Chamaecyparis lawsoniana</i>	52	16	Poor	Codominant leader at 0.7 m. Evident crown dieback. Potentially suffering from drought. UBC tree tag 4840. DBH 34+18.	~15 years	Low	Large	Low	Low
